SPECIAL- SAFETY & OCCUPATIONAL HEALTH BULLETIN #03-03

SUBJECT: M915A3 *TIRE & LUG NUTS*. WARNING

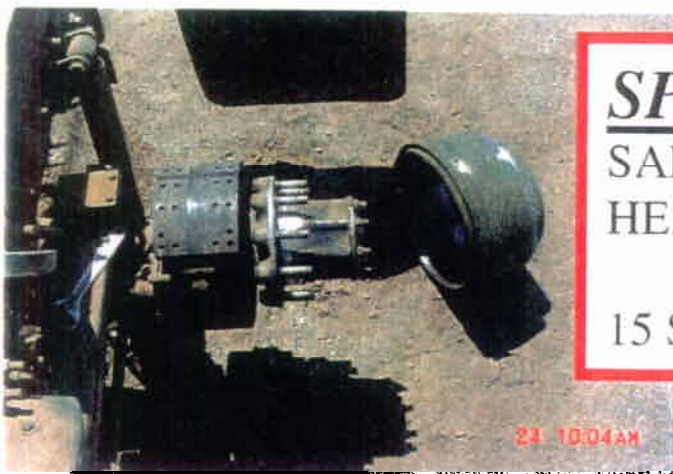
1. A CA ARNG M915A3 truck recently lost two of its rear drivers side tires due to the lug nuts not being tightened properly.
2. Fortunately the vehicle was only traveling 20-25 MPH, and damage was minimal to the vehicle itself, surrounding vehicles and property. Occupants sustained only minor injuries.
3. Maintenance personnel and drivers will ensure the lug nuts are tightened securely before, during and after operating this vehicle. On most Army vehicles the lugs on the passenger side are tightened to the right and the driver's side to the left. However, on the M915A3, ALL sides are tightened to the 'RIGHT'.
4. Corrective and/or preventive maintenance and driver PMCS will be used immediately to prevent any further occurrences of this nature. Drivers are to refer to TM 9-2320-302-10 and maintenance personnel to TM 9-2320-302-20, for further instructions and information.
